**Flood Control Project Maintenance
Levee Inspections****LMA District Cover Sheet****Spring 2014 Levee Inspection Results****Sacramento Maintenance Yard Putah Creek**

Spring 2014 Levee Inspection Results

Sacramento Maintenance Yard Putah Creek

Waterway			Bank	Unit Miles
Unit No. 01 Putah Creek or North Levee			Left	8.99
	Spring (March - May)	Summer (June - August)	(September - November) Fall	Winter (December - February)
Unit Maintenance Rating (Fall Only)				
Date of Inspection	04/14/2014 - 04/14/2014			
DWR Inspector	Herman Phillips			
Accompanied By

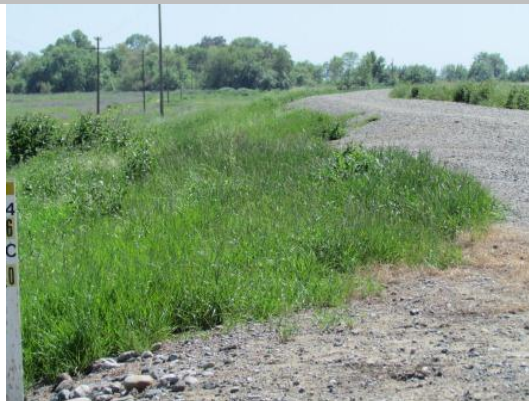
Photo 1 of 1 : phillips_s_20140417_779.jpg

LM Start	0.05	Rating **	M	Issue No.	34
LM End	4.11	Issue Type +	Ma	Location *	WS
Category	Earthen Levee			GPS Latitude/Longitude	
				Start	End
Item	Vegetation			38.522960 °	38.518773 °
				-121.631474 °	-121.699529 °
DWR ID	DWR_ST0007_01_s_2014_34				
Action/Comments					
Control annual grass and weeds on the levee slopes and easements.

Tall grasses visible on the waterward slope during Spring Inspection I know that the Sacramento Maintenance Yard will mow the slopes.
Photo taken 4-14-2014.

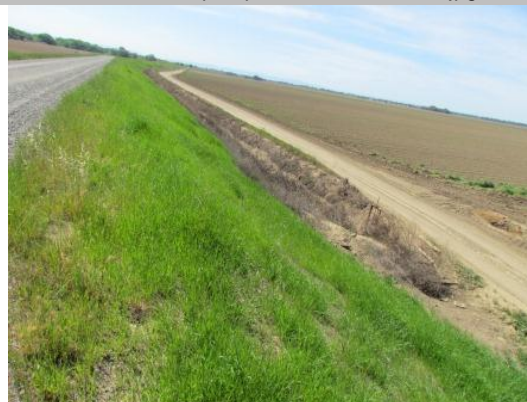
Photo 1 of 1 : phillips_s_20140417_780.jpg

LM Start	1.51	Rating **	U	Issue No.	10
LM End	2.72	Issue Type +	En	Location *	LS
Category	Earthen Levee			GPS Latitude/Longitude	
				Start	End
Item	Encroachments			38.515322 °	38.517376 °
				-121.654387 °	-121.676054 °
DWR ID	DWR_ST0007_01_s_2012_10				
Action/Comments					
Ditch					
Inspector Comments: This agriculture ditch is owned by Dos Rios Farms. Ending at levee mile 2.72 landside.

Agriculture ditch within 10-foot of levee toe landside. Photo taken 4-14-2014.

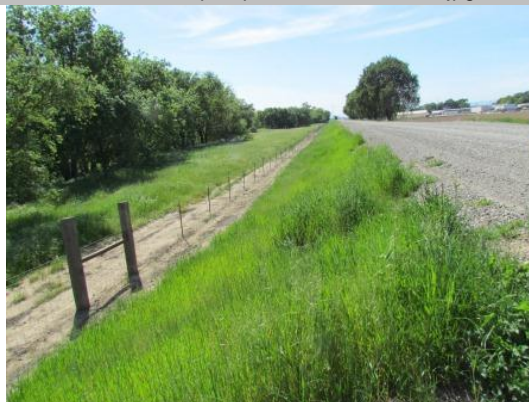
Photo 1 of 1 : phillips_s_20140417_781.jpg

LM Start	3.31	Rating **	U	Issue No.	4
LM End	3.69	Issue Type +	En	Location *	WS
Category	Earthen Levee			GPS Latitude/Longitude	
				Start	End
Item	Encroachments			38.519831 °	38.520011 °
				-121.686263 °	-121.689552 °
DWR ID	DWR_ST0007_01_s_2013_4				
Action/Comments					
Fence

This fence has no known Permit and is within 10-foot of levee toe waterside. Photo taken 4-14-2014.

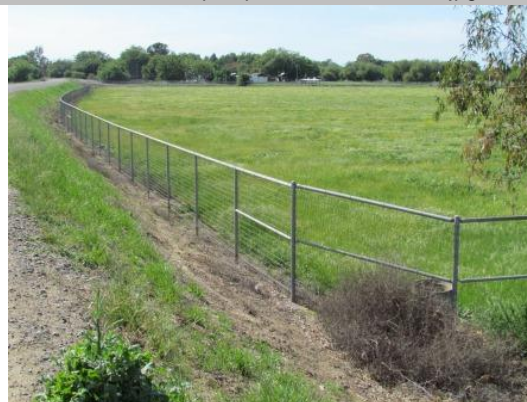
Photo 1 of 1 : phillips_s_20140417_778.jpg

LM Start	6.76	Rating **	M	Issue No.	5
LM End	6.84	Issue Type +	En	Location *	LS
Category	Earthen Levee			GPS Latitude/Longitude	
				Start	End
Item	Encroachments			38.517746 °	38.517647 °
				-121.747220 °	-121.748679 °
DWR ID	DWR_ST0007_01_s _ 2012_5				
Action/Comments					
Fence					
Inspector Comments: This fence has been in the area for many years.					
Levee mile 6.70-6.84 landside within10-foot of easement.

Fence at levee mile 6.76-6.84 landside within 10-foot of toe. This is not a new encroachment. Photo taken 4-14-2014.

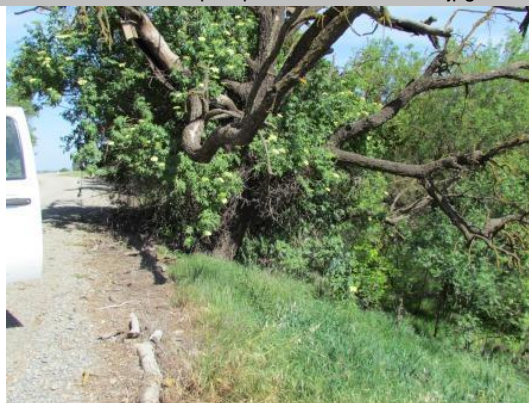
Photo 1 of 2 : phillips_s_20140417_782.jpg

LM Start	7.02	Rating **	U	Issue No.	42
LM End	7.05	Issue Type +	Ma	Location *	WS
Category	Earthen Levee			GPS Latitude/Longitude	
				Start	End
Item	Vegetation			38.517633 °	38.517586 °
				-121.751856 °	-121.752444 °
DWR ID	DWR_ST0007_01_s _ 2014_42				
Action/Comments					
Trees / Woody Vegetation

This tree on the waterside slope is dead and could possibly fall causing damage to the levee section and to Pedestrians. Some branches have broken off and are on the waterside slope. Photo taken 4-14-2014. (Levee mile 7.05)

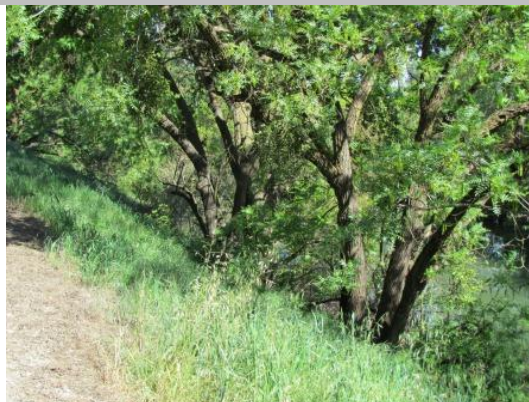
Photo 2 of 2 : phillips_s_20140417_783.jpg

This woody growth of trees water side could cause problem during Flood Fight. Photo taken 4-14-2014 (Levee mile 7.02).

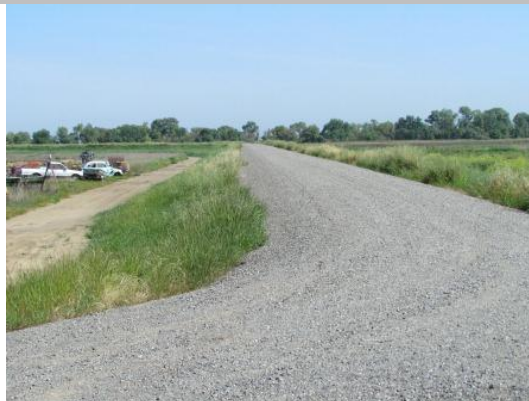
Photo 1 of 1 : phillips_s_20140417_784.jpg

LM Start	0.01	Rating **	M	Issue No.	27
LM End	1.87	Issue Type +	Ma	Location *	LS
Category	Earthen Levee			GPS Latitude/Longitude	
				Start	End
Item	Vegetation			38.504929 °	38.515219 °
				-121.663215 °	-121.689978 °
DWR ID	DWR_ST0007_02_s _ 2014_27				
Action/Comments					
Control annual grass and weeds on the levee slopes and easements.

Looking downstream from levee mile 0.01 landside slope. Photo taken 4-15-2014.

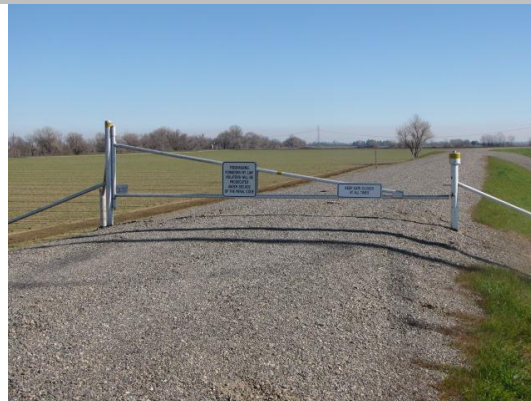
Photo 1 of 3 : phillips_s_20140417_785.jpg

LM Start	0.55	Rating **	U	Issue No.	29
LM End	0.55	Issue Type +	En	Location *	CR
Category	Earthen Levee			GPS Latitude/Longitude	
				Start	End
Item	Encroachments			38.510249 °	38.510249 °
				-121.667551 °	-121.667551 °
DWR ID	DWR_ST0007_02_s_2013_29				
Action/Comments					
Fence

This gate and barricade structure across levee crown and both levee slopes; waterside and landside has no approved CVFPB Permit on file.
Photo taken 4-15-2014.

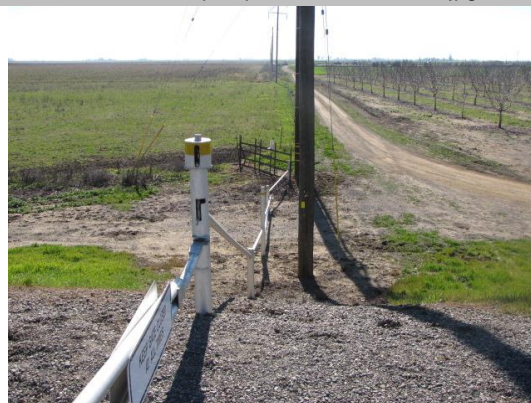
Photo 2 of 3 : phillips_s_20140417_786.jpg

Pipe enclosure extends down landside slope with a pipe gate within 10-foot of levee toe. Photo taken 4-15-2014.

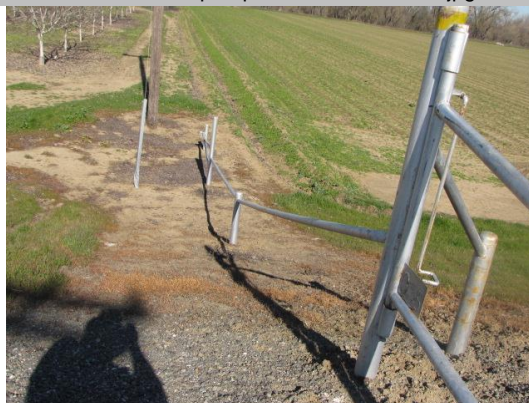
Photo 3 of 3 : phillips_s_20140417_787.jpg

Pipe enclosure extends down waterside slope with a pipe gate within 10-foot of the levee toe. Photo taken 4-15-2014.

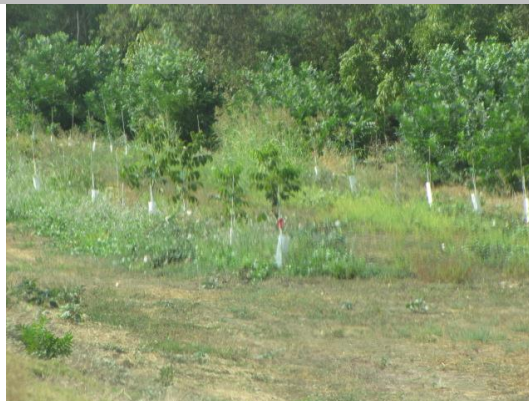
Photo 1 of 1 : phillips_s_20140414_773.jpg

LM Start	6.54	Rating **	U	Issue No.	10
LM End	6.67	Issue Type +	En	Location *	WS
Category	Earthen Levee			GPS Latitude/Longitude	
				Start	End
Item	Encroachments			38.517596 °	38.518361 °
				-121.771910 °	-121.774050 °
DWR ID	DWR_ST0007_02_s _ 2014_10				
Action/Comments					
Tree or limb					
Inspector Comments: There are 62 unauthorized walnut trees planted on the waterward ward berm, no permit. During the Spring inspection 4-15-2014 no new photo was taken of this issue.

Putah Creek levee mile 6.54-6.76 unauthorized planting of walnut trees waterward berm. Photo taken 9-25-2012. These trees are still at location 4-15-2014. No new photo was taken.

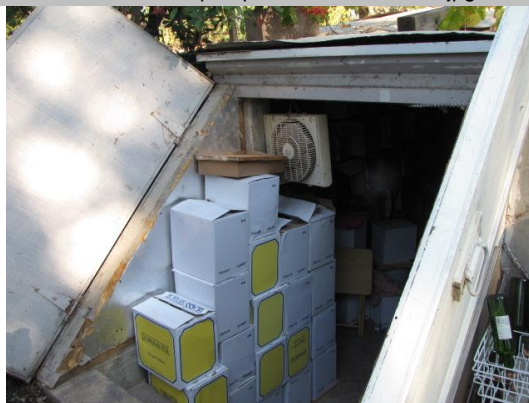
Photo 1 of 1 : phillips_s_20140414_775.jpg

LM Start	6.79	Rating **	U	Issue No.	18
LM End	6.79	Issue Type +	En	Location *	LS
Category	Earthen Levee			GPS Latitude/Longitude	
				Start	End
Item	Encroachments			38.522722 °	38.522722 °
				-121.784898 °	-121.784900 °
DWR ID	DWR_ST0007_02_s _ 2012_18				
Action/Comments					
Building					
Inspector Comments: Unit 2 Putah Creek approx. levee mile 6.79 the property owner has an underground wine cellar within the landward levee slope. We have no knowledge how long its been there. This site is under review 2013. No new photo was taken 4-15-2014. Problem still being looked at by CVFP Board.

Unauthorized wine cellar.

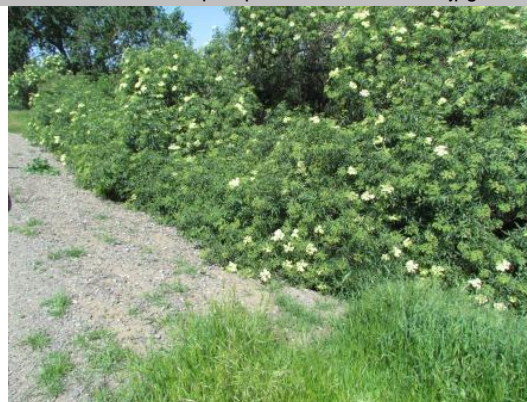
Photo 1 of 1 : phillips_s_20140417_776.jpg

LM Start	6.95	Rating **	U	Issue No.	38
LM End	7.06	Issue Type +	Ma	Location *	WS
Category	Earthen Levee			GPS Latitude/Longitude	
				Start	End
Item	Vegetation			38.520602 °	38.521467 °
				-121.778191 °	-121.779795 °
DWR ID	DWR_ST0007_02_s _ 2014_38				
Action/Comments					
Elderberries are blocking visibility and flood fight capability.

Looking downstream at elderberry trees blocking the view of the waterward slope and toe. Photo taken 4-15-2014.

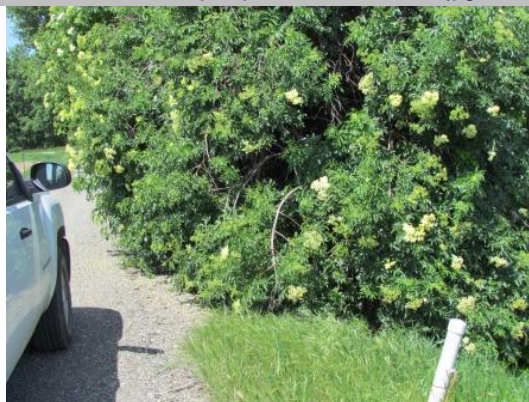
Photo 1 of 1 : phillips_s_20140417_777.jpg

LM Start	7.07	Rating **	U	Issue No.	39
LM End	7.17	Issue Type +	Ma	Location *	WS
Category	Earthen Levee			GPS Latitude/Longitude	
				Start	End
Item	Vegetation			38.521537 °	38.522311 °
				-121.779999 °	-121.781450 °
DWR ID	DWR_ST0007_02_s _ 2014_39				
Action/Comments					
Elderberries are blocking visibility and flood fight capability.

View of overgrown elderberry trees blocking the the shoulder slope and toe of the waterside levee section. Photo taken 4-15-2014.
